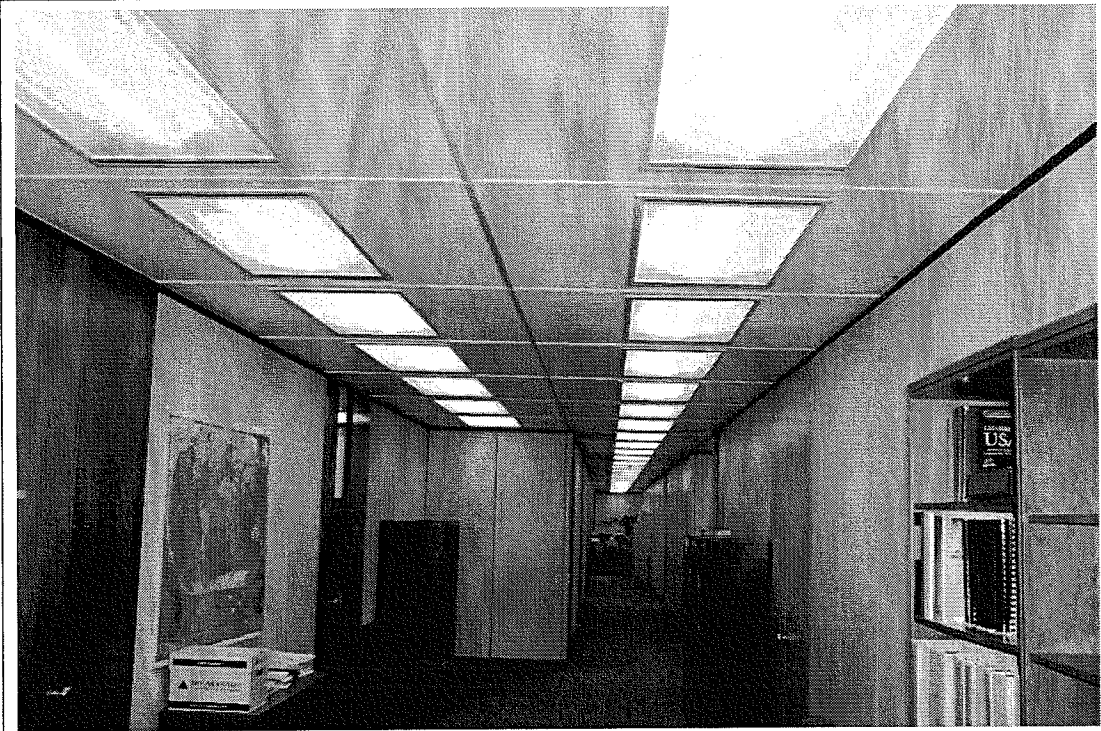
Photo 62. 19th floor, SE corner of bldg - General view of light fixture/ceiling grid system in hallway

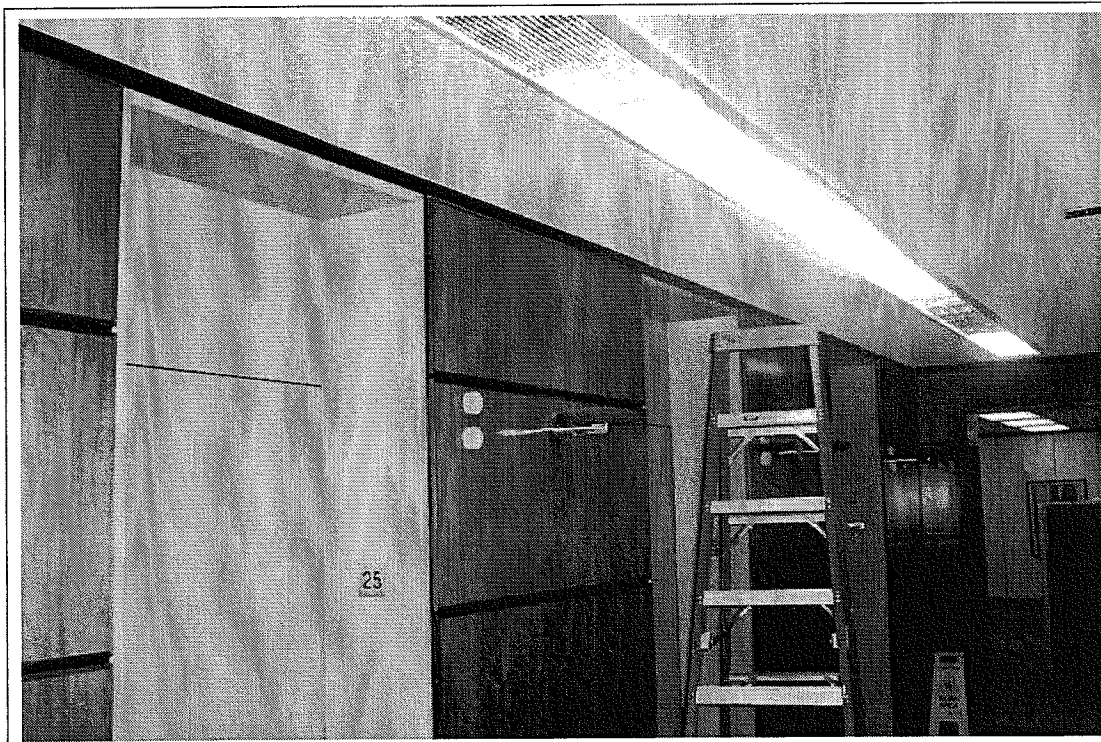
Photo 63. 25th floor, northside of elevator lobby - General view of acoustical spray ceiling above elevators

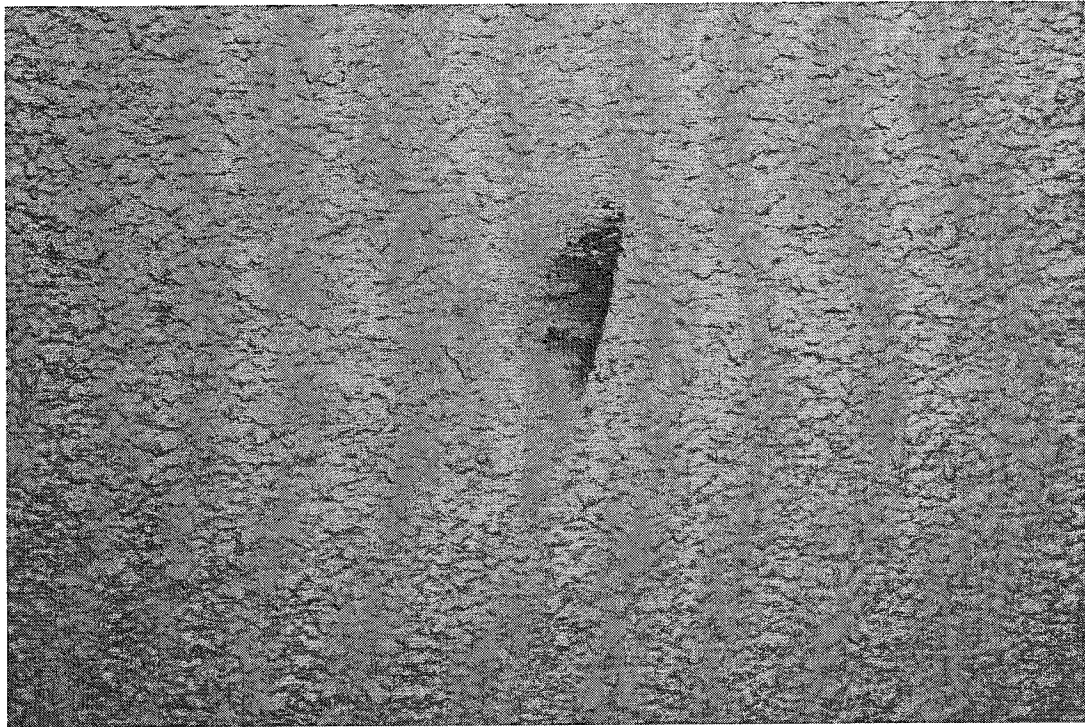
Photo 64. 19th floor, elevator lobby - center - View of impact damage to acoustical spray finish

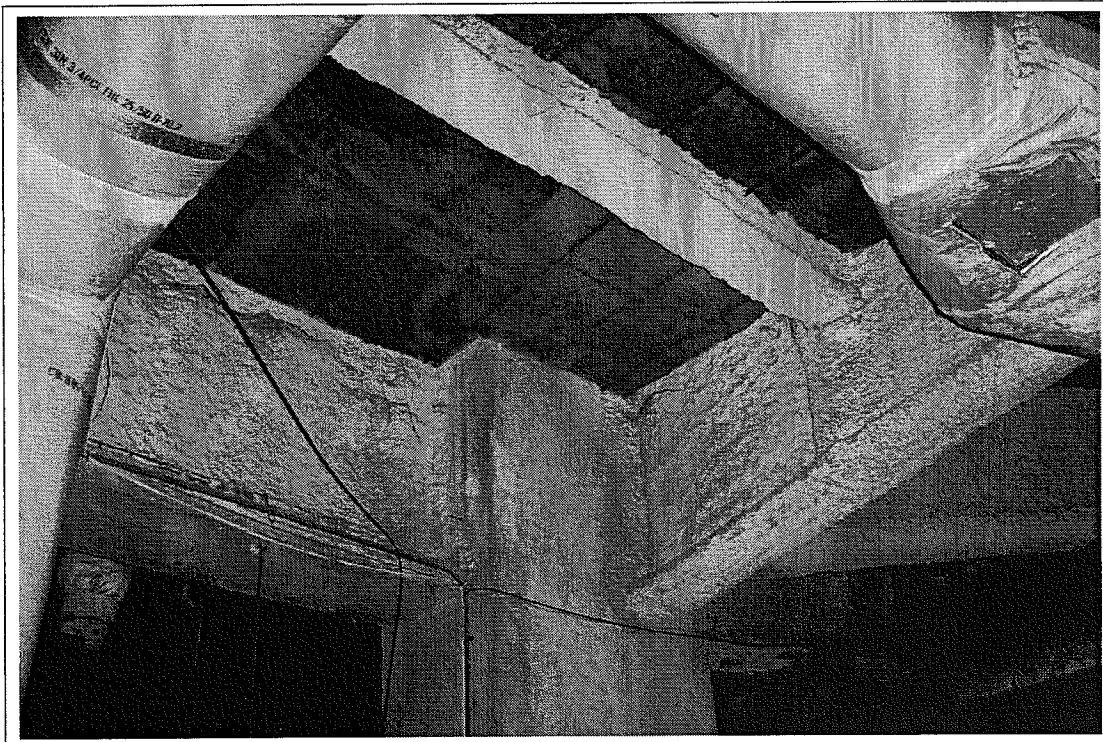
Photo 65. 1st floor, NW mechanical room - View of exposed fireproofed structural members

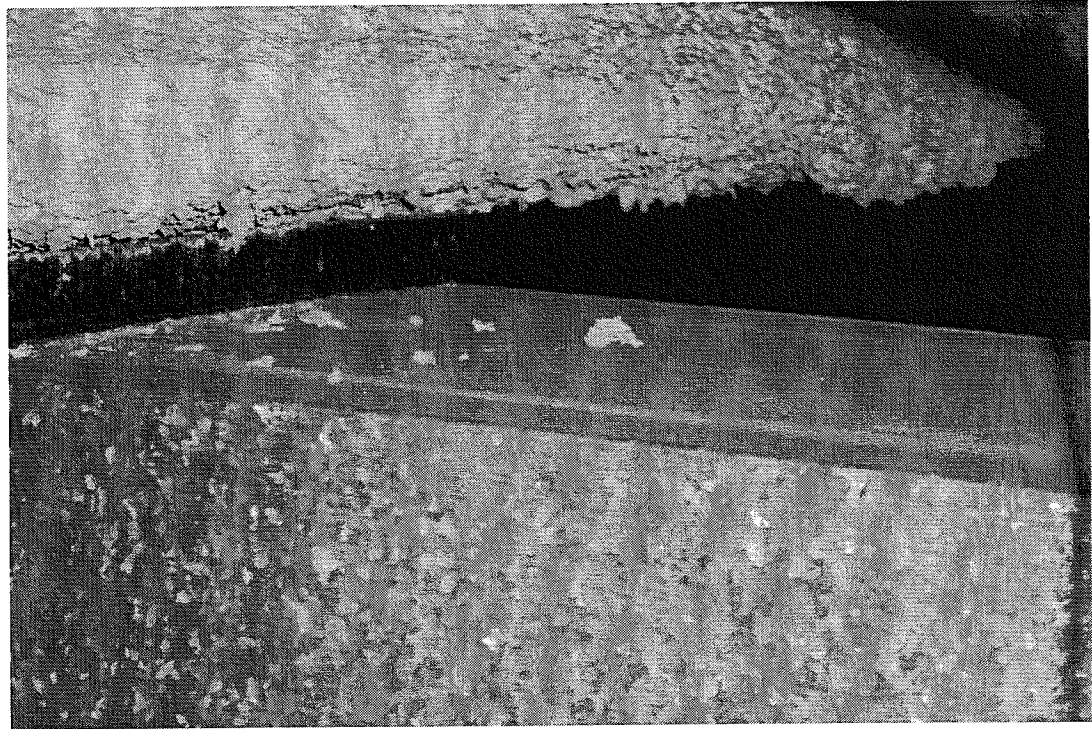
Photo 66. 24th floor, adjacent to room W2412B - View of dislodged fireproofing debris on top of metal HVAC duct

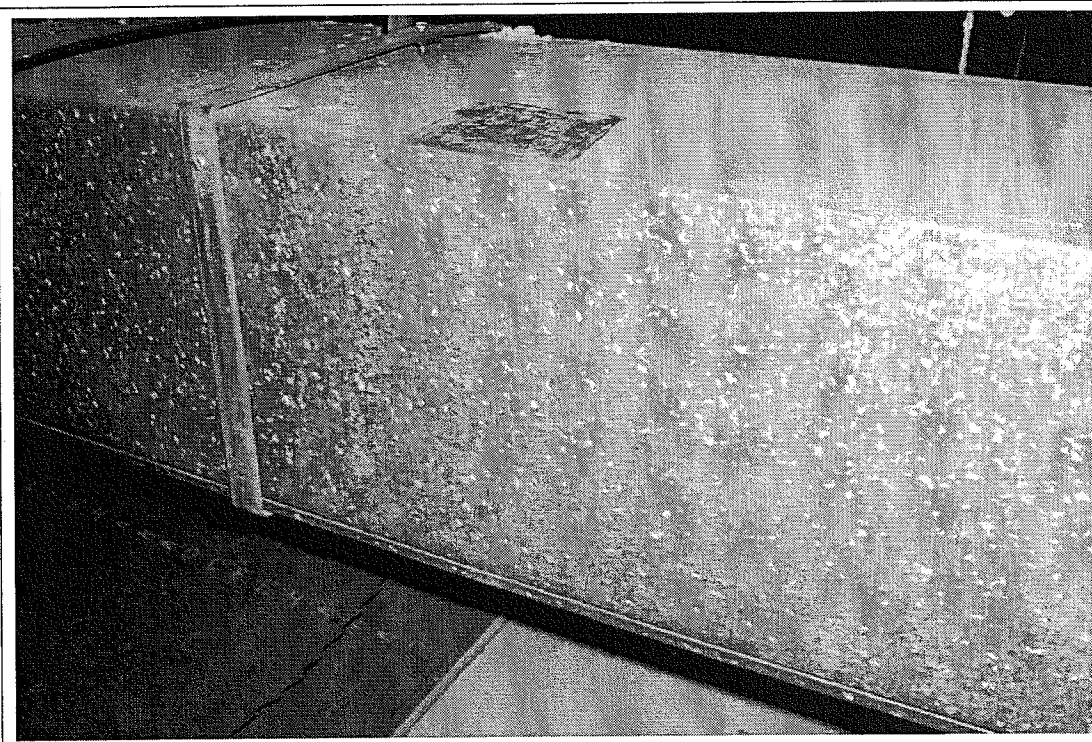
Photo 67. 24th floor, adjacent to room W2412B - Location of dust sample #1
